Inspection Report

Minerals Regulatory Program

Mine Name: Smokey Joe	Permit Number: M/049/0002	Permit Fees: Paid		
Operator Name: Interstate Brick Co.	Inspection Date: June 20, 2013	Bond Amount: \$62,400.00		
Inspector(s): A. Abate, L. Kunzler, T. Nicolaysen	Time: 11:00 AM	Bond Escalation: past due 9/2011		
Others:	Mine Status: Inactive			
Elements of Inspection		Evaluated	Comment	Enforcement

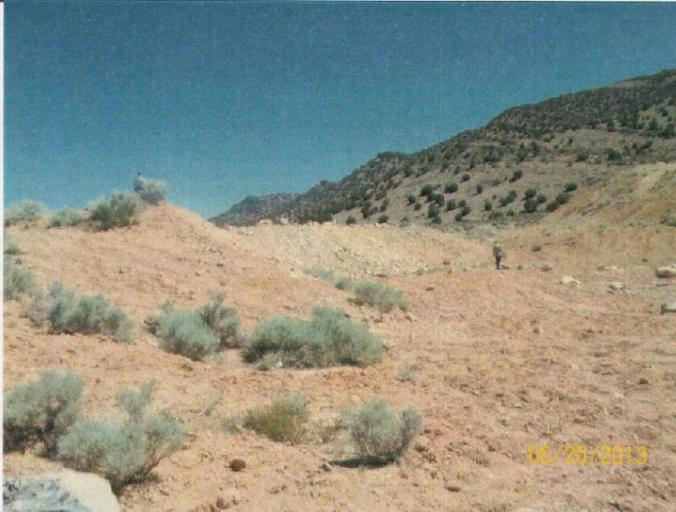
Highwall on the west side of the mine facing northwest is still too high - needs grading.

Verify that dumps on the far west side are part of the permit area. These slopes should be graded if they are. Request operator to meet with Division in the field to discuss reclamation work.

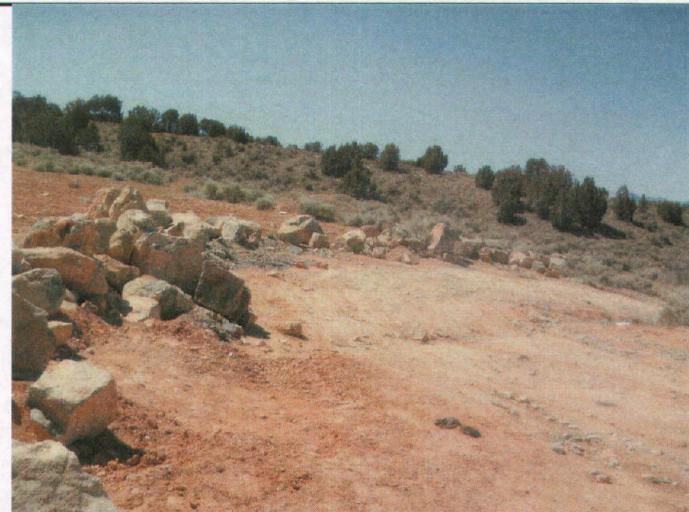
View of the boulders that have been placed separating the mine from the road. The boulders for the most part block access but there are still areas where access is possible for off road vehicles.

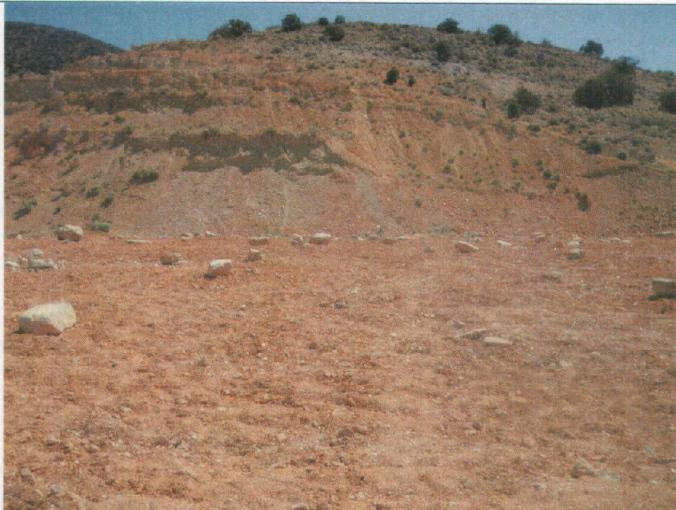
Highwall view: ATV tracks have been removed since May 2013 inspection.

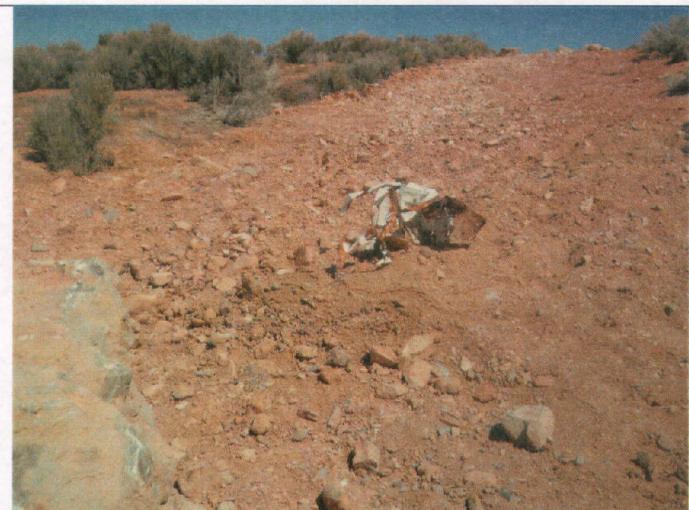
Trash and shell casing are still present at the site and need to be disposed of.
